## **Hazard indicators in urban trees. Case studies on *Platanus x hispanica* Mill. ex Münchh and *Morus alba* L. in Mendoza city-Argentina \***

Claudia Fernanda Martinez <sup>1\*</sup>, Ana Paula Coelho-Duarte <sup>2</sup>

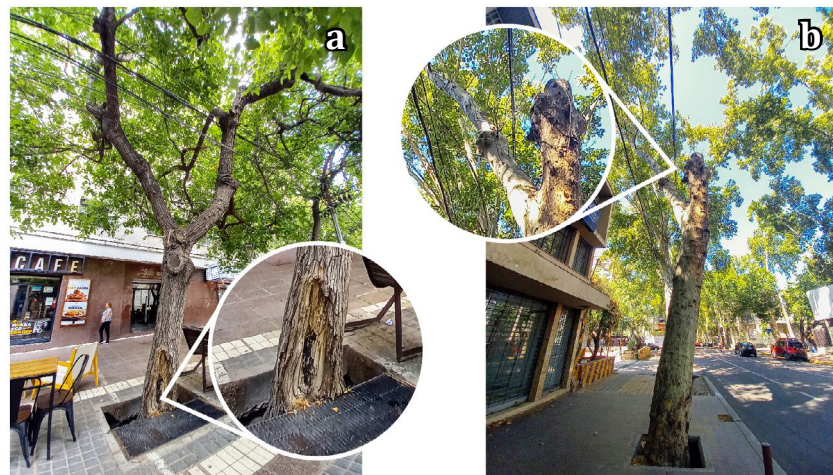
In 63% of London Plane trees and 74% of Mulberry trees, some type of decay was observed during the assessment circuit, most of it due to severe or inadequate pruning, in which the trees are not able to complete wound compartmentalization (figure 2, page 156). Cavities with rotten wood were observed in trunks, while branch advanced decay with large pruning cuts showed, in some cases, wound wood and in others, loss of wood and cavities. No fungal fruiting bodies were observed during data collection, probably caused by the study taking part during late summer-autumn, with high temperatures.

In London Plane trees, wound wood formation was observed, even when pruning cuts or wounds caused by vehicular traffic, were large (figure 2).

**Figure 2.** Decay defect observed on **a-** *Morus alba* on Peatonal Sarmiento and **b-** *Platanus hispanica* with dry branches on Montevideo Street.

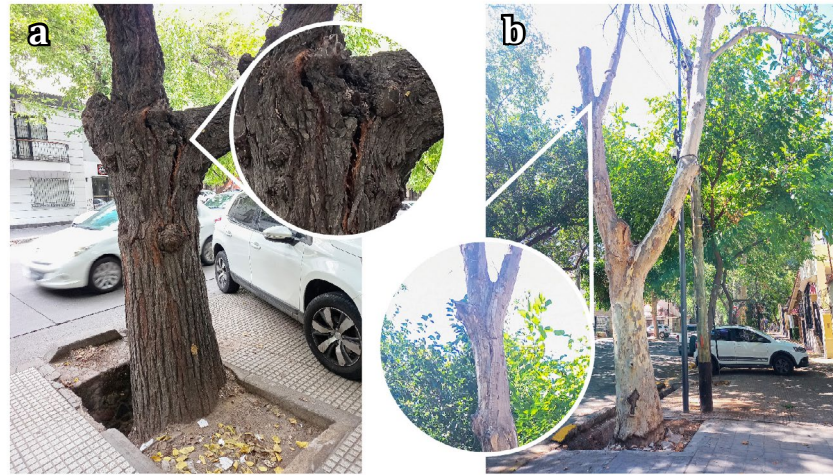
A crack is a separation in the wood tissue (16), and one major defect in more severe cases as they indicate the tree is already failing (20). Cracks can be formed when a trunk or branch does not support a certain load, either due to poorly closed wounds, split of weak unions or branches with overloaded limbs (2). They can also be caused by frost damage or sunscald (28). Vertical cracks following the direction of longitudinal fibers, were present in 48% of Mulberry trees, combined with the presence of codominant V-shaped stems and decay (figure 3a, page 157). In London Plane trees, they were rarely observed (13%), mostly associated with dead wood (figure 3b, page 157). These defects have a high to imminent likelihood of failure, and treatment should be recommended.

**Figure 3.** Crack defect in **a-** *Morus alba* and **b-** *Platanus hispanica*.  
**Figura 3.** Defecto de grietas en **a-** *Morus alba* y **b-** *Platanus hispanica*.

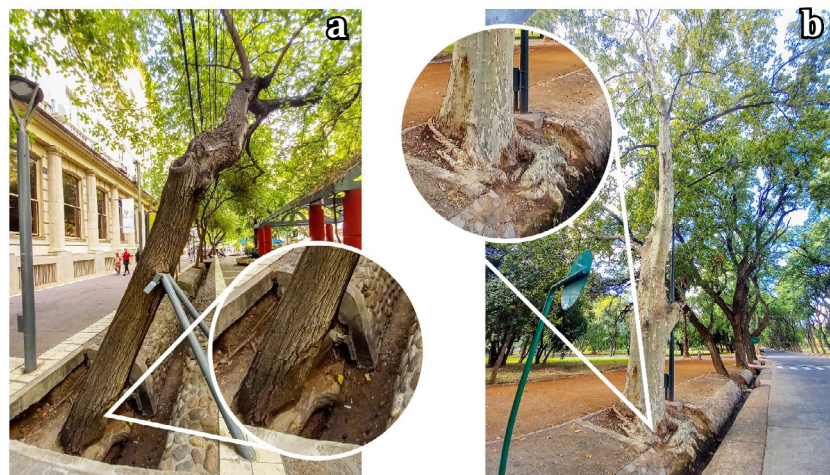
Site factors such as reduced space for root development, shallow, compacted, or poor soil, cause tree decline in urban areas (27). Limited space for root growth of these first magnitude species, such as London Plane trees, and second magnitude like Mulberry trees, is compounded by impermeabilized irrigation ditches of Mendoza. Although this does not normally result in direct tree damage, decreasing soil moisture and oxygen availability, reduces tree ability to recover from injury, insect attack and/or disease (5). Also, root weakness results in loss of anchorage and support (28), increasing the possibility of whole-tree overturning. Thus, significant changes in the critical root radius (CRR) can lead to a high failure potential especially when more than 40% of the roots within this zone are damaged (9, 20). In Mulberry trees, impacts of ditch impermeabilization were observed in 19% of the trees (figure 4a, page 157). In 50% of London Plane trees some root problems were observed, such as girdling and exposed roots in search of oxygen (figure 4b, page 157).

**Figure 4.** Root problems related to pot dimensions or planting site, and impermeabilization; **a-** *Morus alba*; **b-** *Platanus hispanica*.  
**Figura 4.** Problemas del sistema radical relacionado con las dimensiones de la cazuela o sitio de plantación, e impermeabilización; **a-** *Morus alba*; **b-** *Platanus hispanica*.

Girdling roots compress root collar, hindering water, nutrients, and sap transport from and to the roots (9, 10). These roots can originate in the nursery itself, in seedlings grown in small pots, or when the tree is grown in a small rigid space, where structural roots are unable to grow laterally (16).

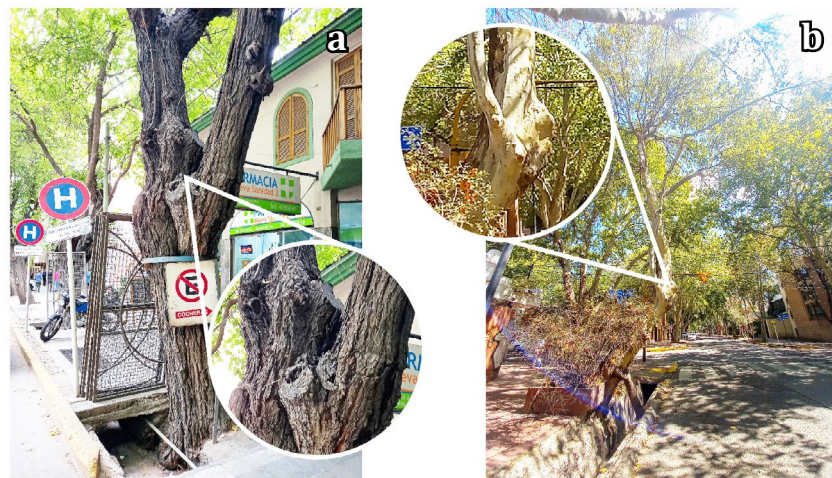
this weak union. On the other hand, included bark may be generated during the development of bifurcated stems or branch insertions which, instead of generating the more cohesive axillary wood, grow with bark between the stems, resulting in no connection between them. This may occur due to an intrinsic species trait, as in those with opposite buds, or after inappropriate management, altering bud development (24). Included bark can be detected by the V-shaped insertion, as opposed to a strong union, which would be U-shaped. Both included bark -especially between codominant stems resulting in opposing loads of similar magnitude- and epicormic shoots are types of weak unions present in trees (20). Eighty-four percent of Mulberry trees showed codominant, V-shaped structural branches with a very small angle of insertion and branches overextended towards the roadside. In some cases, this defect was combined with cracks, cankers, or rots (figure 5a). This makes stem splits the main likelihood of failure. In London Plane trees, 44% had weak unions, mainly in the most intensively managed trees, where the crown is largely made up of epicormic shoots and, in some cases, these weak unions were combined with decayed wood (figure 5b).

**Figure 5.** Defects concerning weak branch unions or codominant stems;  
**a-** *Morus alba*; **b-** *Platanus hispanica*.

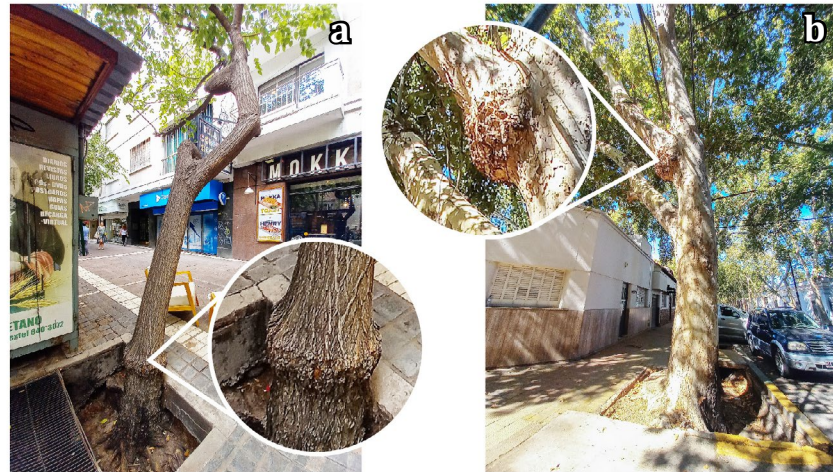
Cankers are areas with damaged cambium (16) on trunks, branches, and roots (2). They can be caused by fungi, insects, lightning or mechanical damage, such as wounds caused by vehicles, lawn mowers, among others. According to Pokorny (2003), regardless of the origin of the damage, more than 40% affectation of the circumference of a tree may cause failure and, in turn, if the canker is associated with decay, it can quickly weaken the tree. In the streets of Mendoza city, cankers were mainly associated with pruning wounds and decay, being recorded in 29% of the Mulberry trees and 75% of the London Plane trees. Figure 6a (page 159), shows a Mulberry tree with abnormal basal growth, appearing as a “wood belt” (16), which may have been caused by damage during changes in the sidewalk. In one specimen of London Plane an abnormal discoloration, combined with branch dieback, may have been associated with disease. In another case, a gall-like growth was observed, with a significant change in bark texture (figure 6b, page 159). According to Mattheck *et al.* (2015), this form is not associated with a severe structural problem. The problem is aggravated when the canker is associated with decayed wood.

**Figure 6.** Canker present in **a- Morus** and **b- Platanus**.

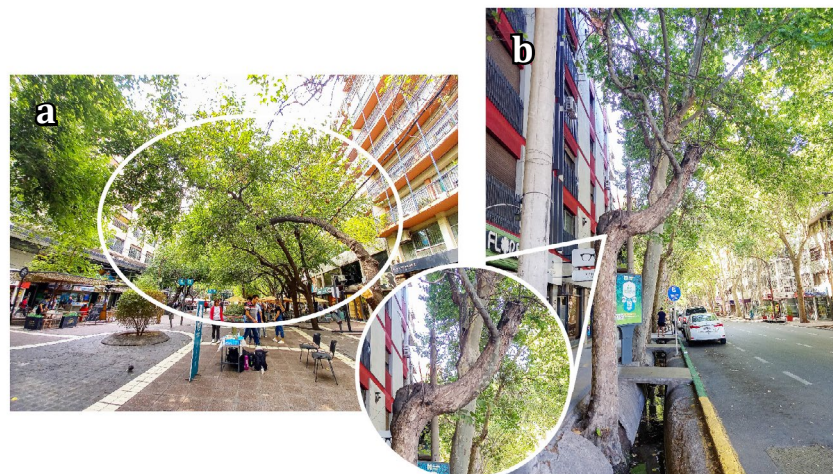
Among the trees assessed, 63% of the London Plane trees and 39% of the Mulberry trees showed some problem related to architecture, especially observed in those subsequently intervened by pruning, resulting in an unbalanced, curved shape (figure 7a) and with overextended branches towards the roadside. Although these indicators, according to Pokorny (2003), correspond to a moderate likelihood of failure, these defects are in some cases combined with the presence of decayed wood (figure 7b).

**Figure 7. a-** Imbalance in the morphology of a Mulberry tree in Peatonal Sarmiento.

**b-** London Plane tree with poor architecture accompanied by decayed wood.

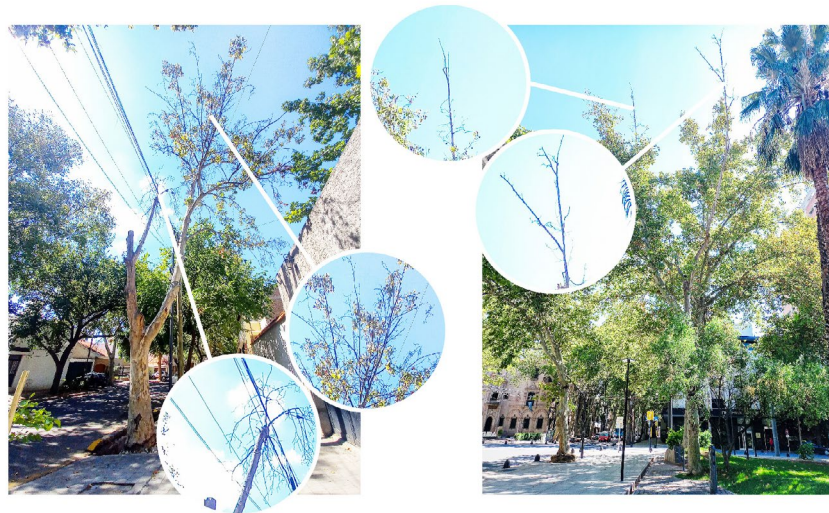
Dead branches can remain attached to the tree for a long time, and suddenly break off as they no longer have the tension that keeps them attached (20). This was observed in 3% Mulberry trees, and 44% London Plane trees, especially where impermeabilisation hindered water availability (figure 8). The dieback observed in London Plane specimens may be associated with site factors leading to root decay, such as soil compaction or impermeabilisation that impede root gas exchange reducing root mass and, consequently, water and nutrient absorption (16). As a result, the tree starts to die out from the branch tips inwards (20).

**Figure 8.** London Plane individuals showing signs of dieback.

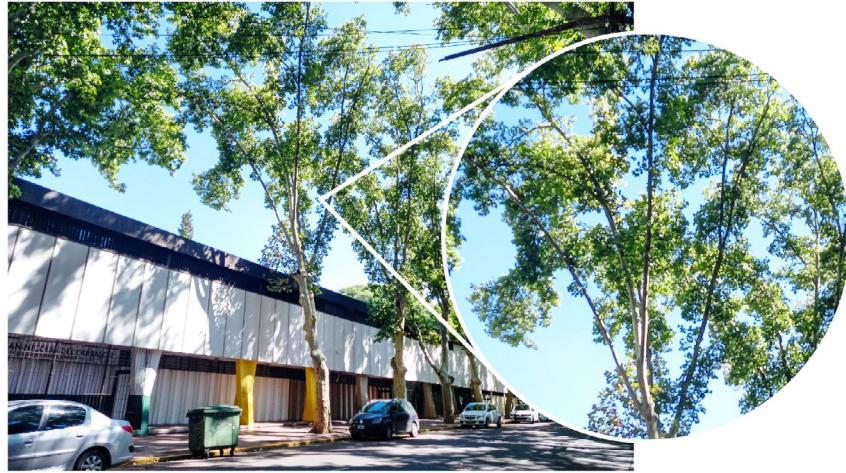
Slender trees may be more prone to mechanical failure, causing permanent bending or stem breakage (8). The slenderness index, characterizing likelihood of failure, is calculated by dividing tree total height by the diameter at breast height (both in meters). Many authors classify the likelihood of failure as possible for slenderness between 60 and 80, probable between 81 and 100, and imminent over 100. When “lion tailing” pruning is done, leaving branches accumulated at the ends of main stems, slenderness is increased. Another factor increasing this index is tree planting near tall buildings, reducing light availability, and promoting growth in height without an increase in trunk diameter (15) something the tree will correct only under healthy, vigorous conditions (28). Figure 9 (page 161), shows this behavior in a London Plane specimen showing signs of crown lifting pruning. In addition, the epicormic origins of these branches, with a weaker union, as well as the presence of non-compartmentalized pruning wounds with decay, can increase likelihood of failure.

**Figure 9.** Defect in London Plane trees compatible with slender individuals.

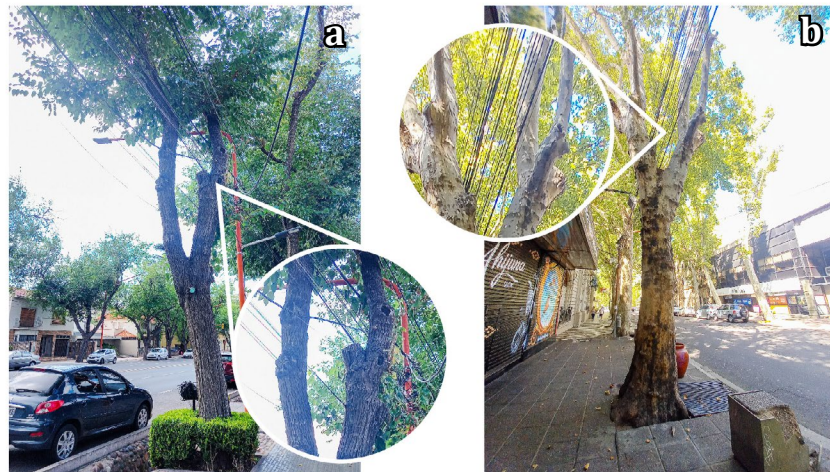
In addition to the risk of structural failure, interference with pedestrian walkways, underground utilities or utility poles and wires should be considered in the risk assessment (6). The presence of aerial utility wiring in the city of Mendoza with either Mulberry or London Plane trees (figure 10, page 161), increases the need for frequent interventions on the tree crown to reduce the occurrence of friction between branches and wires. These conflicts were observed in 94% of the Mulberry trees and 56% of the London Plane trees. Greater deterioration is observed in the Mulberry trees in general, compared to the London Plane trees.

**Figure 10.** Conflicts with utility wiring and lighting poles; **a-** *Morus alba*; **b-** *Platanus hispanica*.

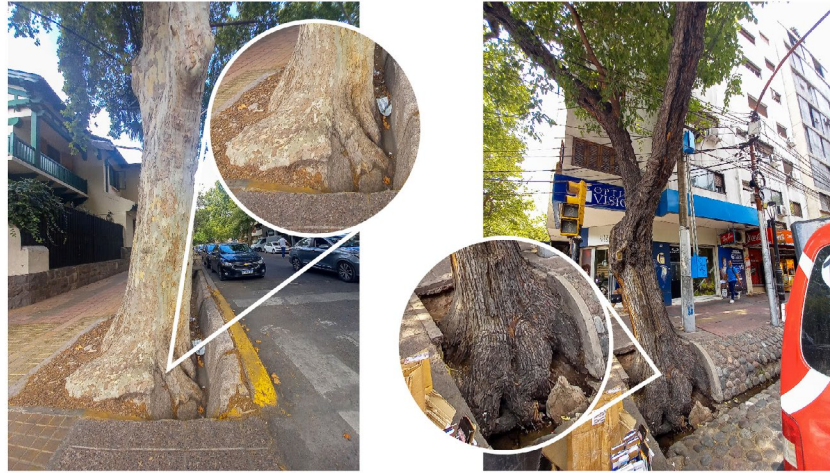
Biomechanics study how trees adapt to different growth sites, climatic conditions, and stresses (2). Ditches create special conditions for root performance, and in many cases, impermeabilization adds resistance making root growth limited. In some individuals of both species, structural roots and root collar growth, was observed above ground level and towards the roadside curb (figure 11, page 162). Although this tissue contains dormant adventitious buds, that become active under stress-generating epicormic shoots, it does not provide the expected structural anchorage (16). In addition, the wood in this area is exposed to mechanical damage and deterioration agents such as fungi and xylophagous insects.

**Figure 11.** Structural roots and root collar growth above ground level.

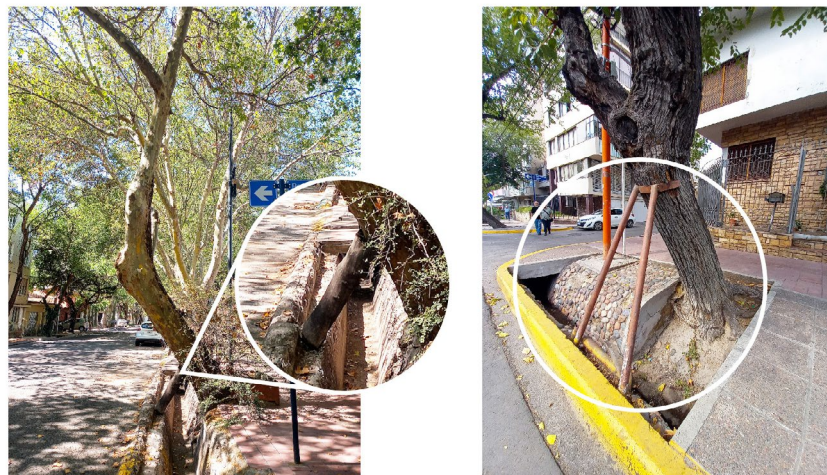
Supports are necessary when the tree has a probable or imminent likelihood of failure due to high pedestrian/vehicle occupancy rate or presence of targets that cannot be moved (12). This generally occurs when tree adaptation is slow compared to the response needed to reduce the hazard. In the study area, supports were observed on Mulberry trees tying co-dominant stems, where a crack separating them was already visible (figure 5a, page 158). Supports were also observed on steeply inclined trees in both species (figure 12).

**Figure 12.** Individuals of *Platanus* and *Morus* with structural supports, orthopedics or "crutches".

When using supports, tree reactions such as wound generation or positive adaptive response must be monitored, and the option of relocating, reinforcing, or removing the support, should be evaluated. However, in some cases, supports generated wounds or cracks, indicating it should have been removed after the tree corrected the lean.
